AL-37 Flight Report

Battery Consumption Flight
April 9, 2022

Boeing Experimental Flight

Iowa State University of Science and Technology

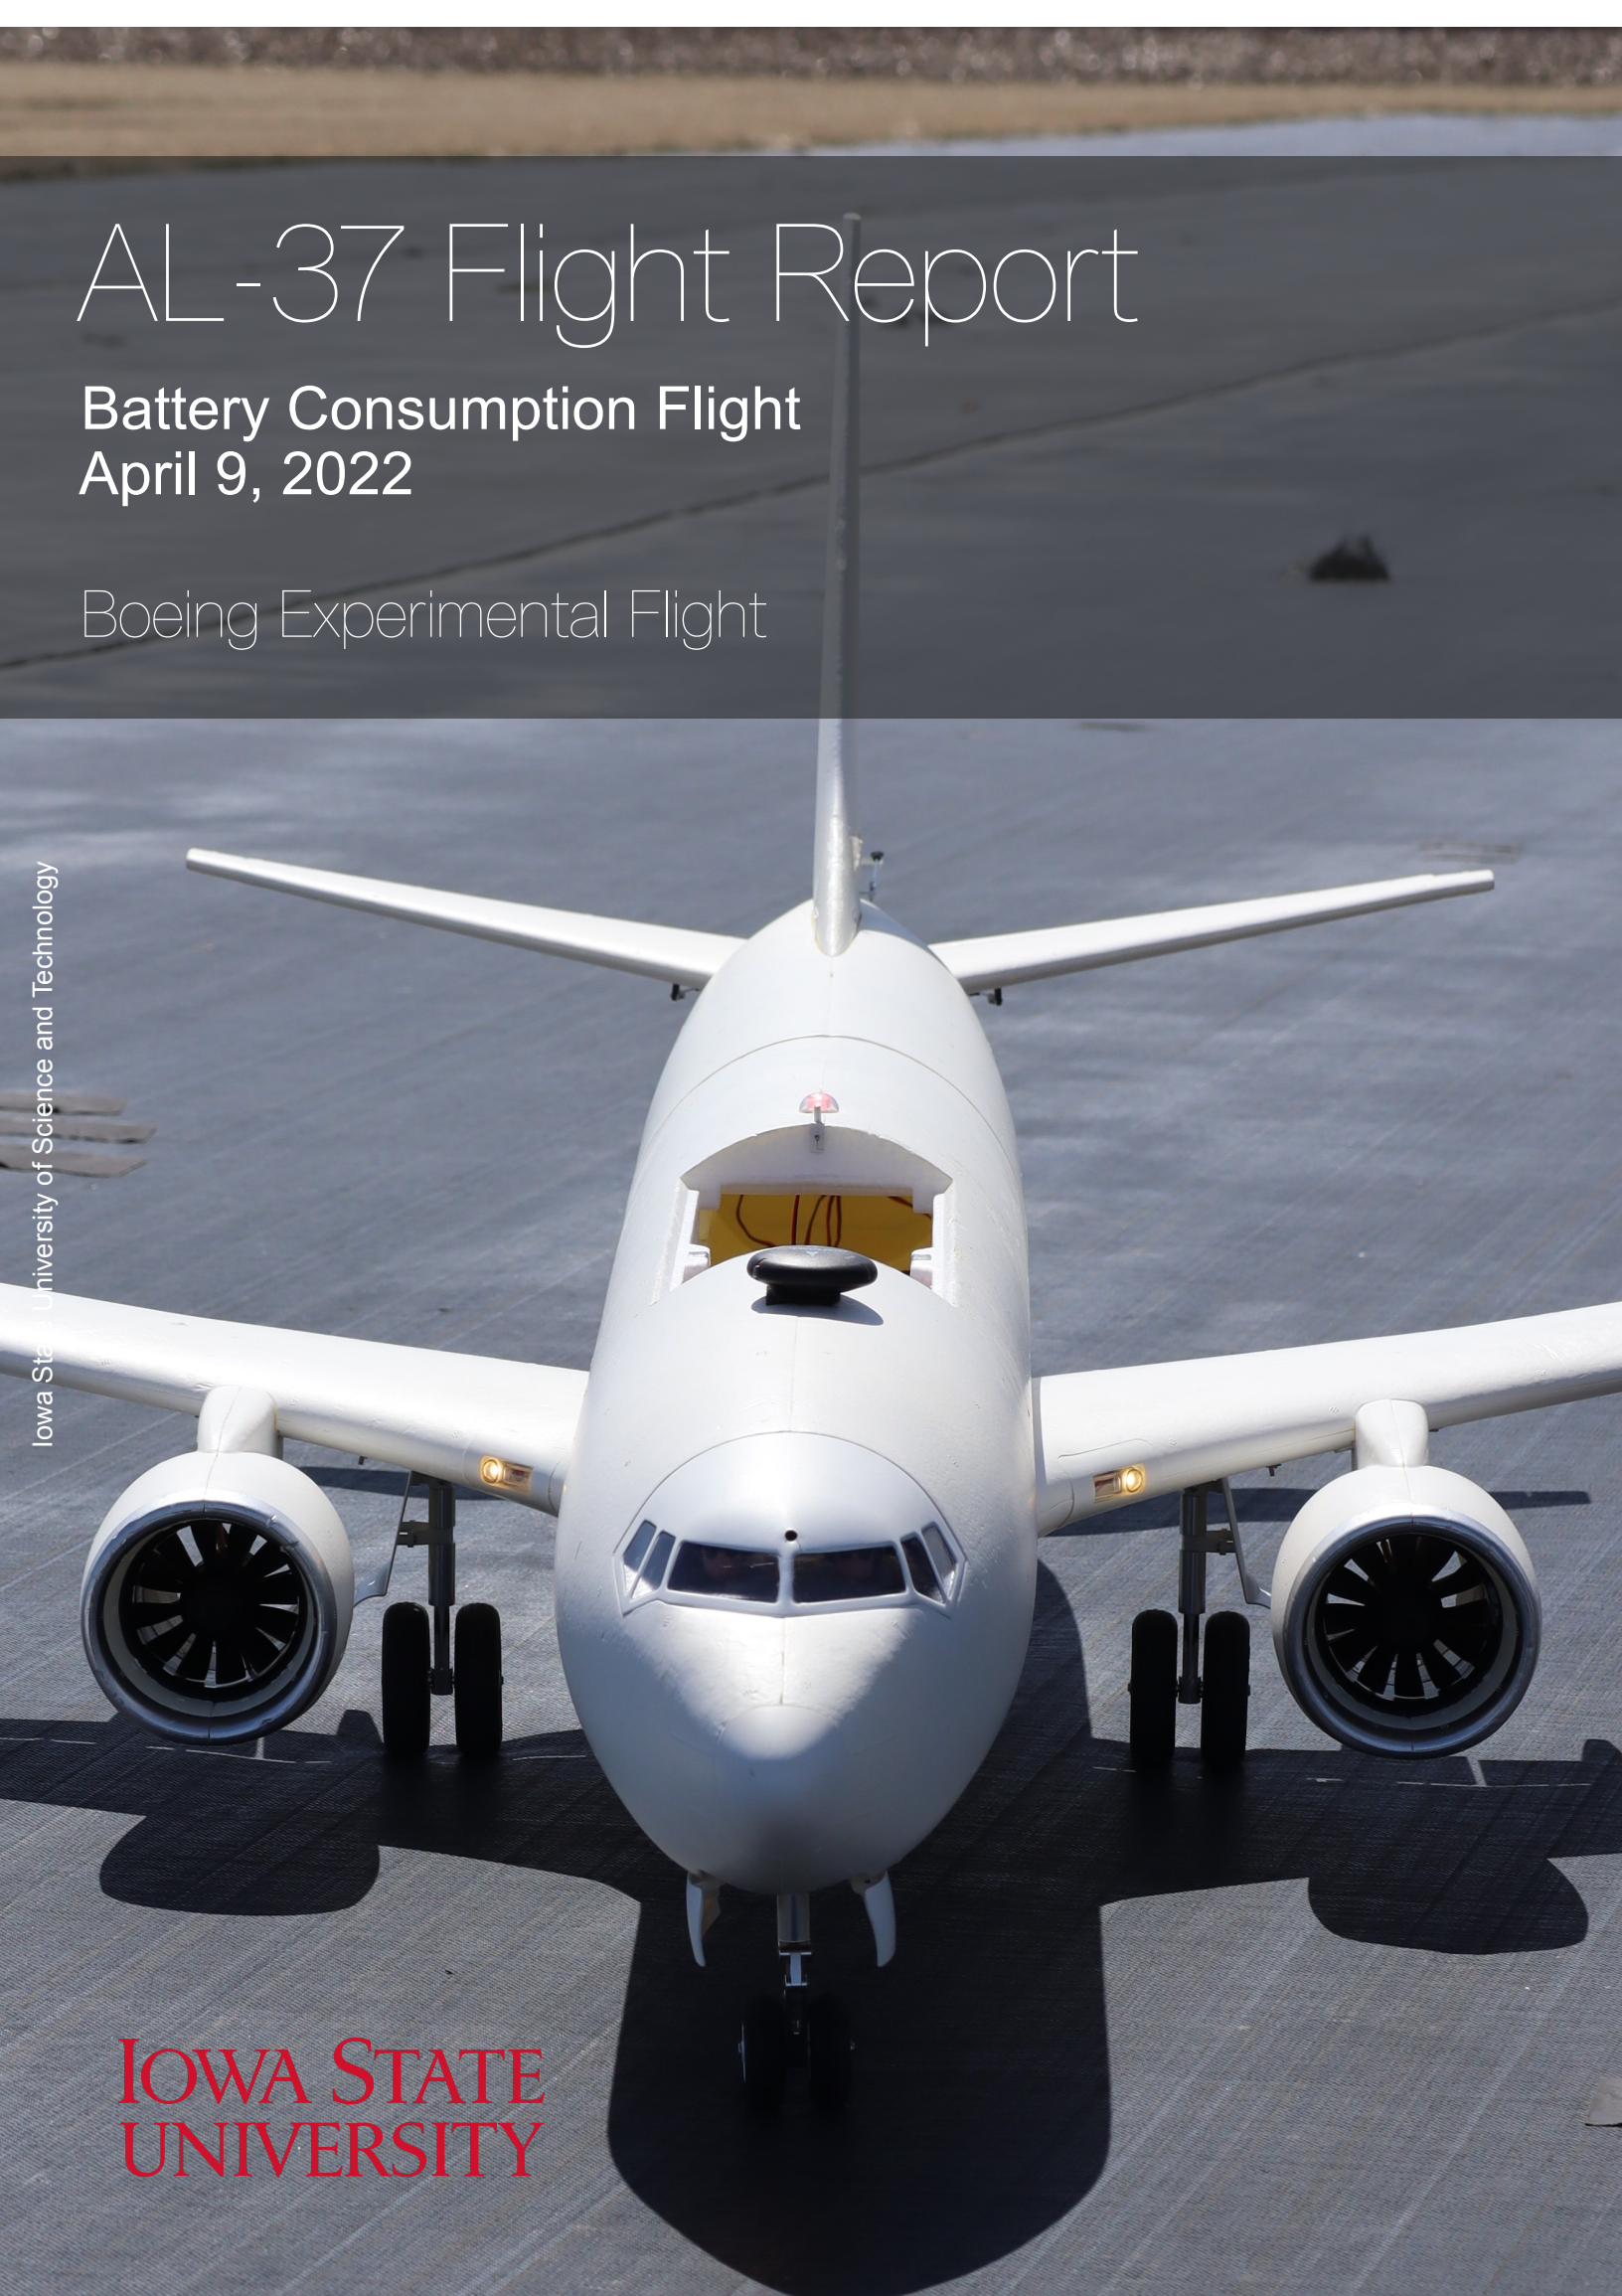
Cover: The AL-37 when the electronics were inspected just after flight.

11. The electronics and exterior were checked for damage
12. The aircraft was taken back to the assembly station, where the battery was disconnected
13. The aircraft was disassembled while the pilot provided final feedback

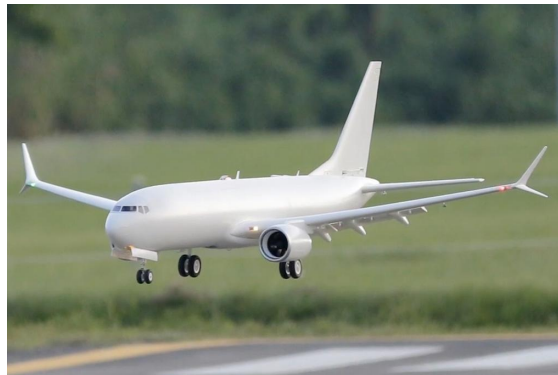
The AL-37 is a remote control aircraft by Freewing. It is a 1/19 scale of the Boeing 737. It is 78.74 inches long and has a wingspan of 72.04 inches. It is powered by two 6S 2952-2100Kv inrunner motors with a 12-Blade EDF (Electric Ducted Fan). It also features a fully operational LED lighting system and retractable landing gear, like an actual Boeing 737. The project's version of the AL-37 has some modified electronics. These include a Pixhawk system to track and record data for the aircraft. The wiring was also modified to allow for the Pixhawk to eventually take automated control over the aircraft.
